Location of APCs and
Mostly Non-Vegetated Areas

ROLLING KNOLLS LANDFILL SUPERFUND SITE
CHATHAM, NEW JERSEY

Figure
5-1

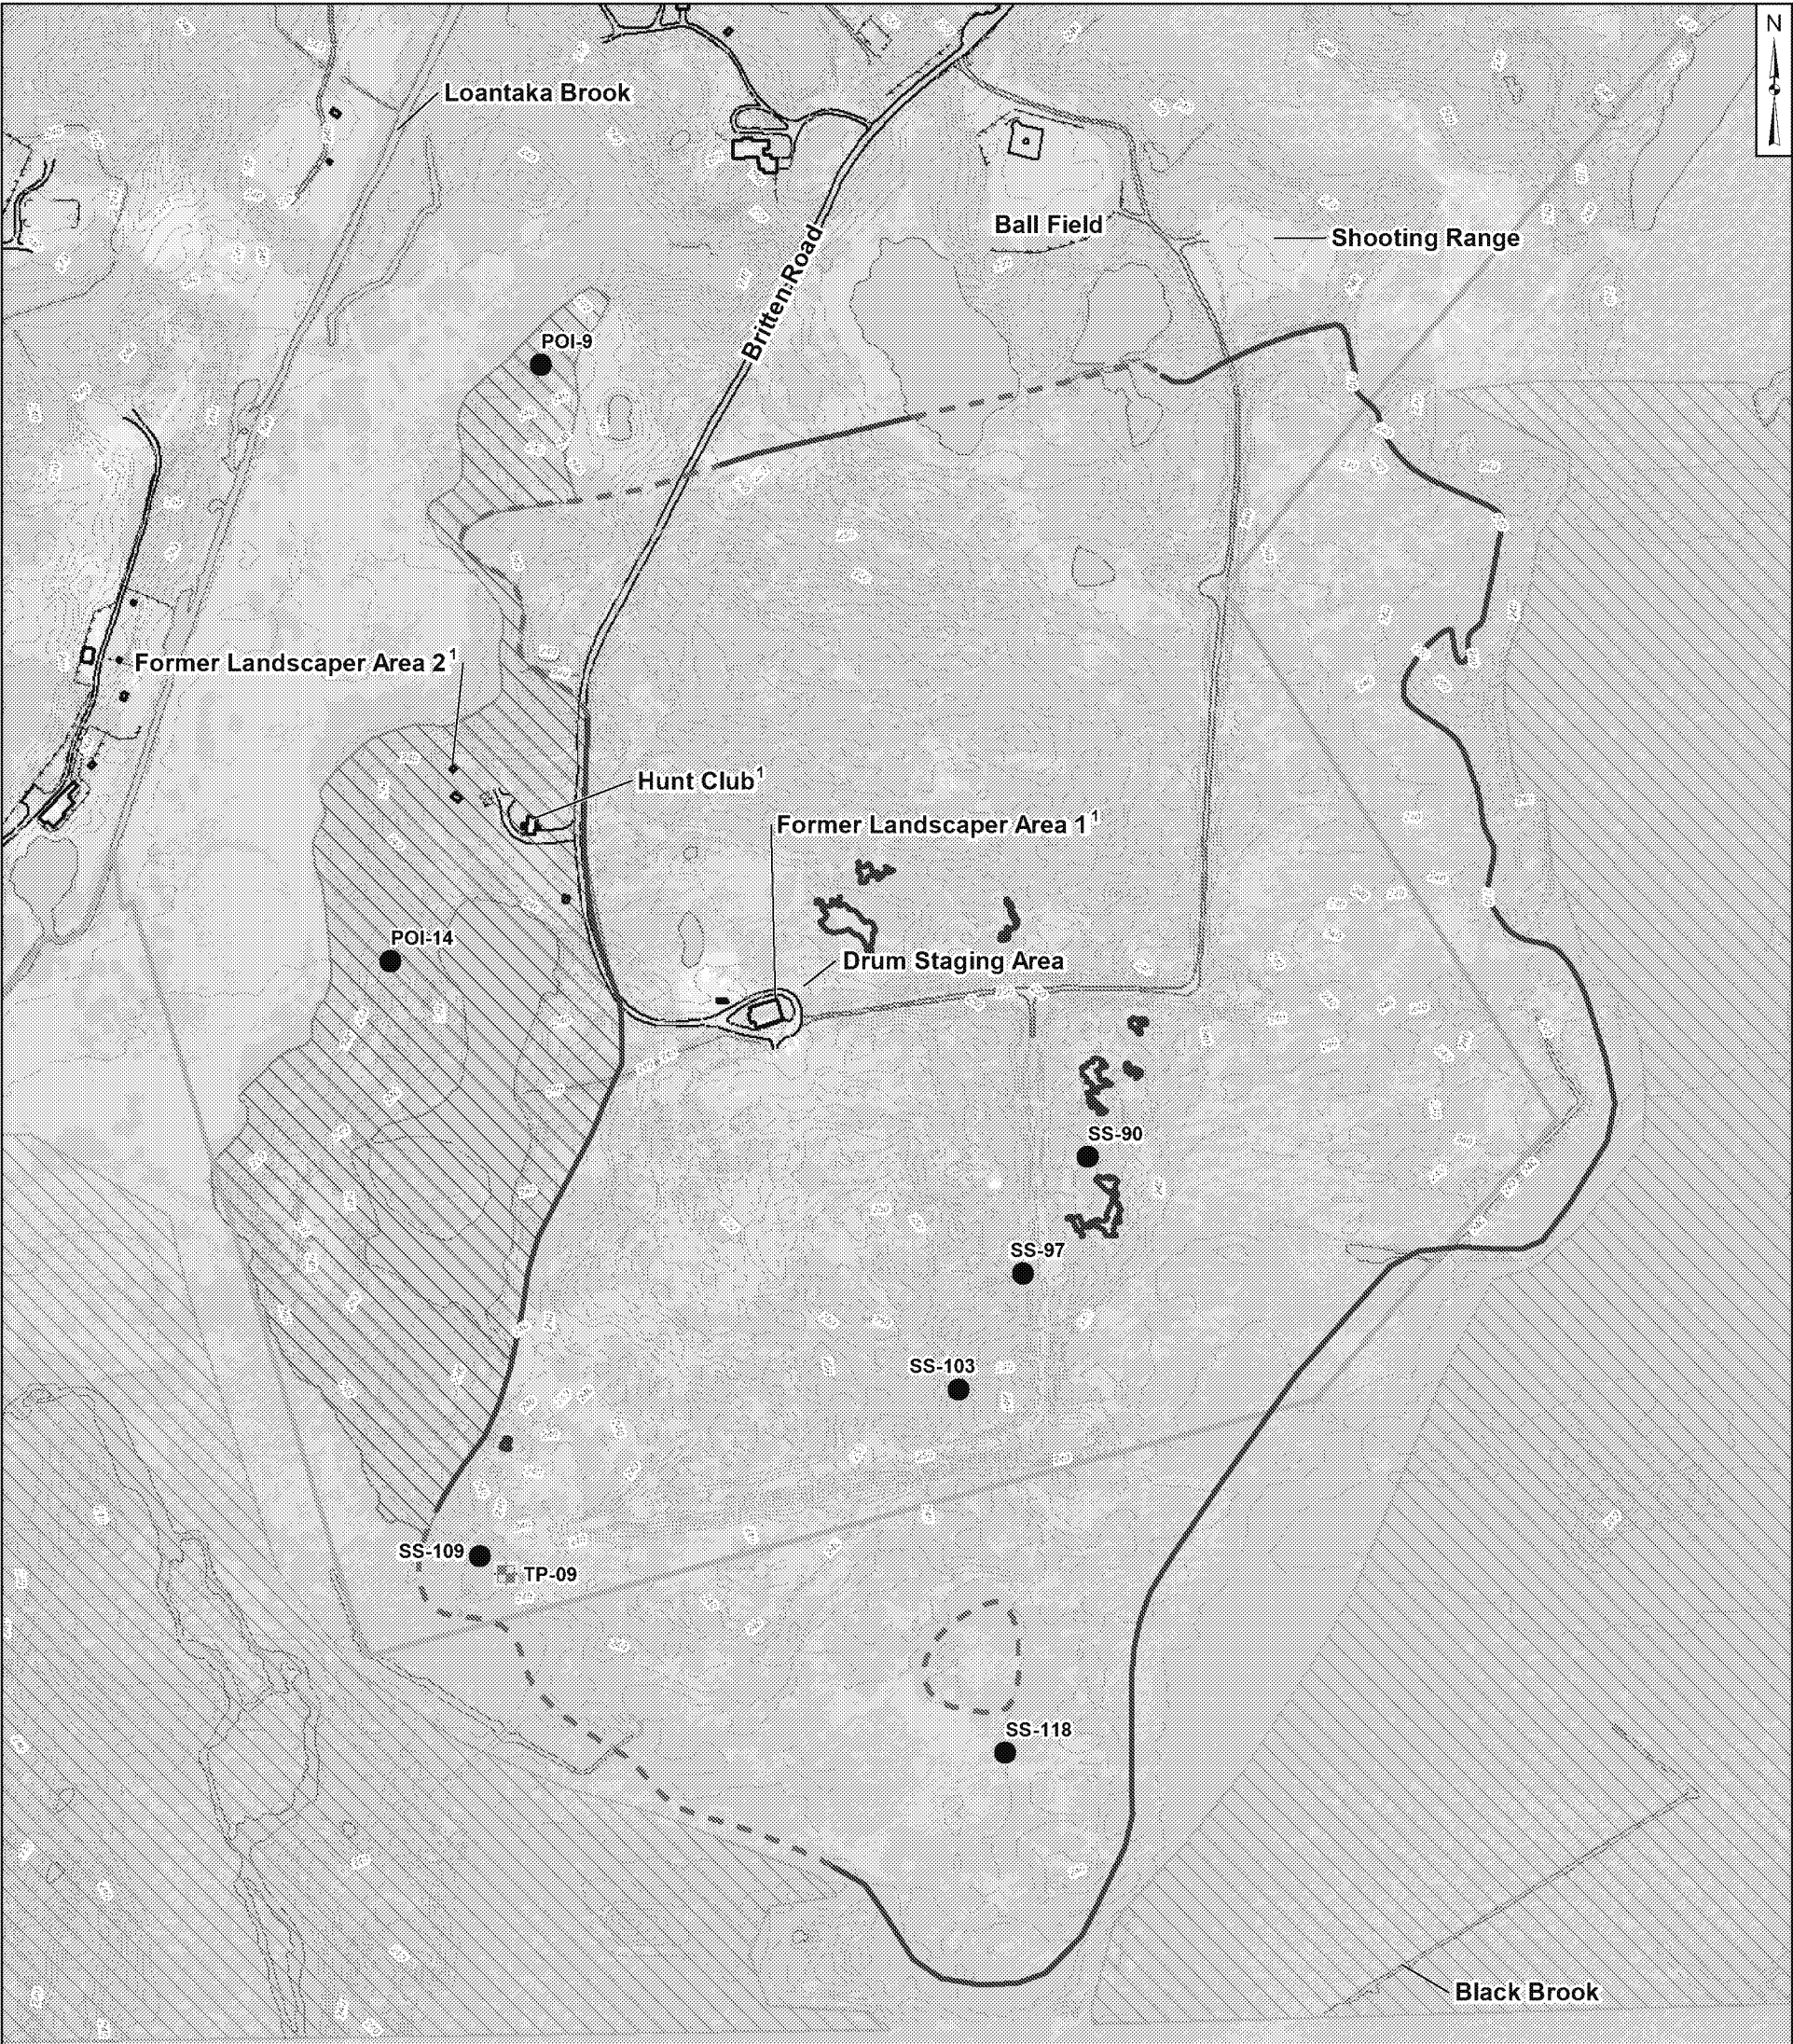
Note 1: These features to be removed from landfill area prior to completion of soil remedy.
Site Plan created from Arcadis CAD drawings received December 2015.
Aerial imagery accessed via ArcGIS Online and provided by the United States Department of Agriculture on 2 May 2018.
Image is dated 31 July 2015.
